INDOOR AIR QUALITY SURVEY

Conducted on January 30, 1997

**SOCIAL SECURITY ADMINISTRATION
DISTRICT OFFICE
717 SOUTH SERVICE ROAD
MOORE, OKLAHOMA**

**THE U.S. PUBLIC HEALTH SERVICE
FEDERAL OCCUPATIONAL HEALTH
Dallas Field Office**

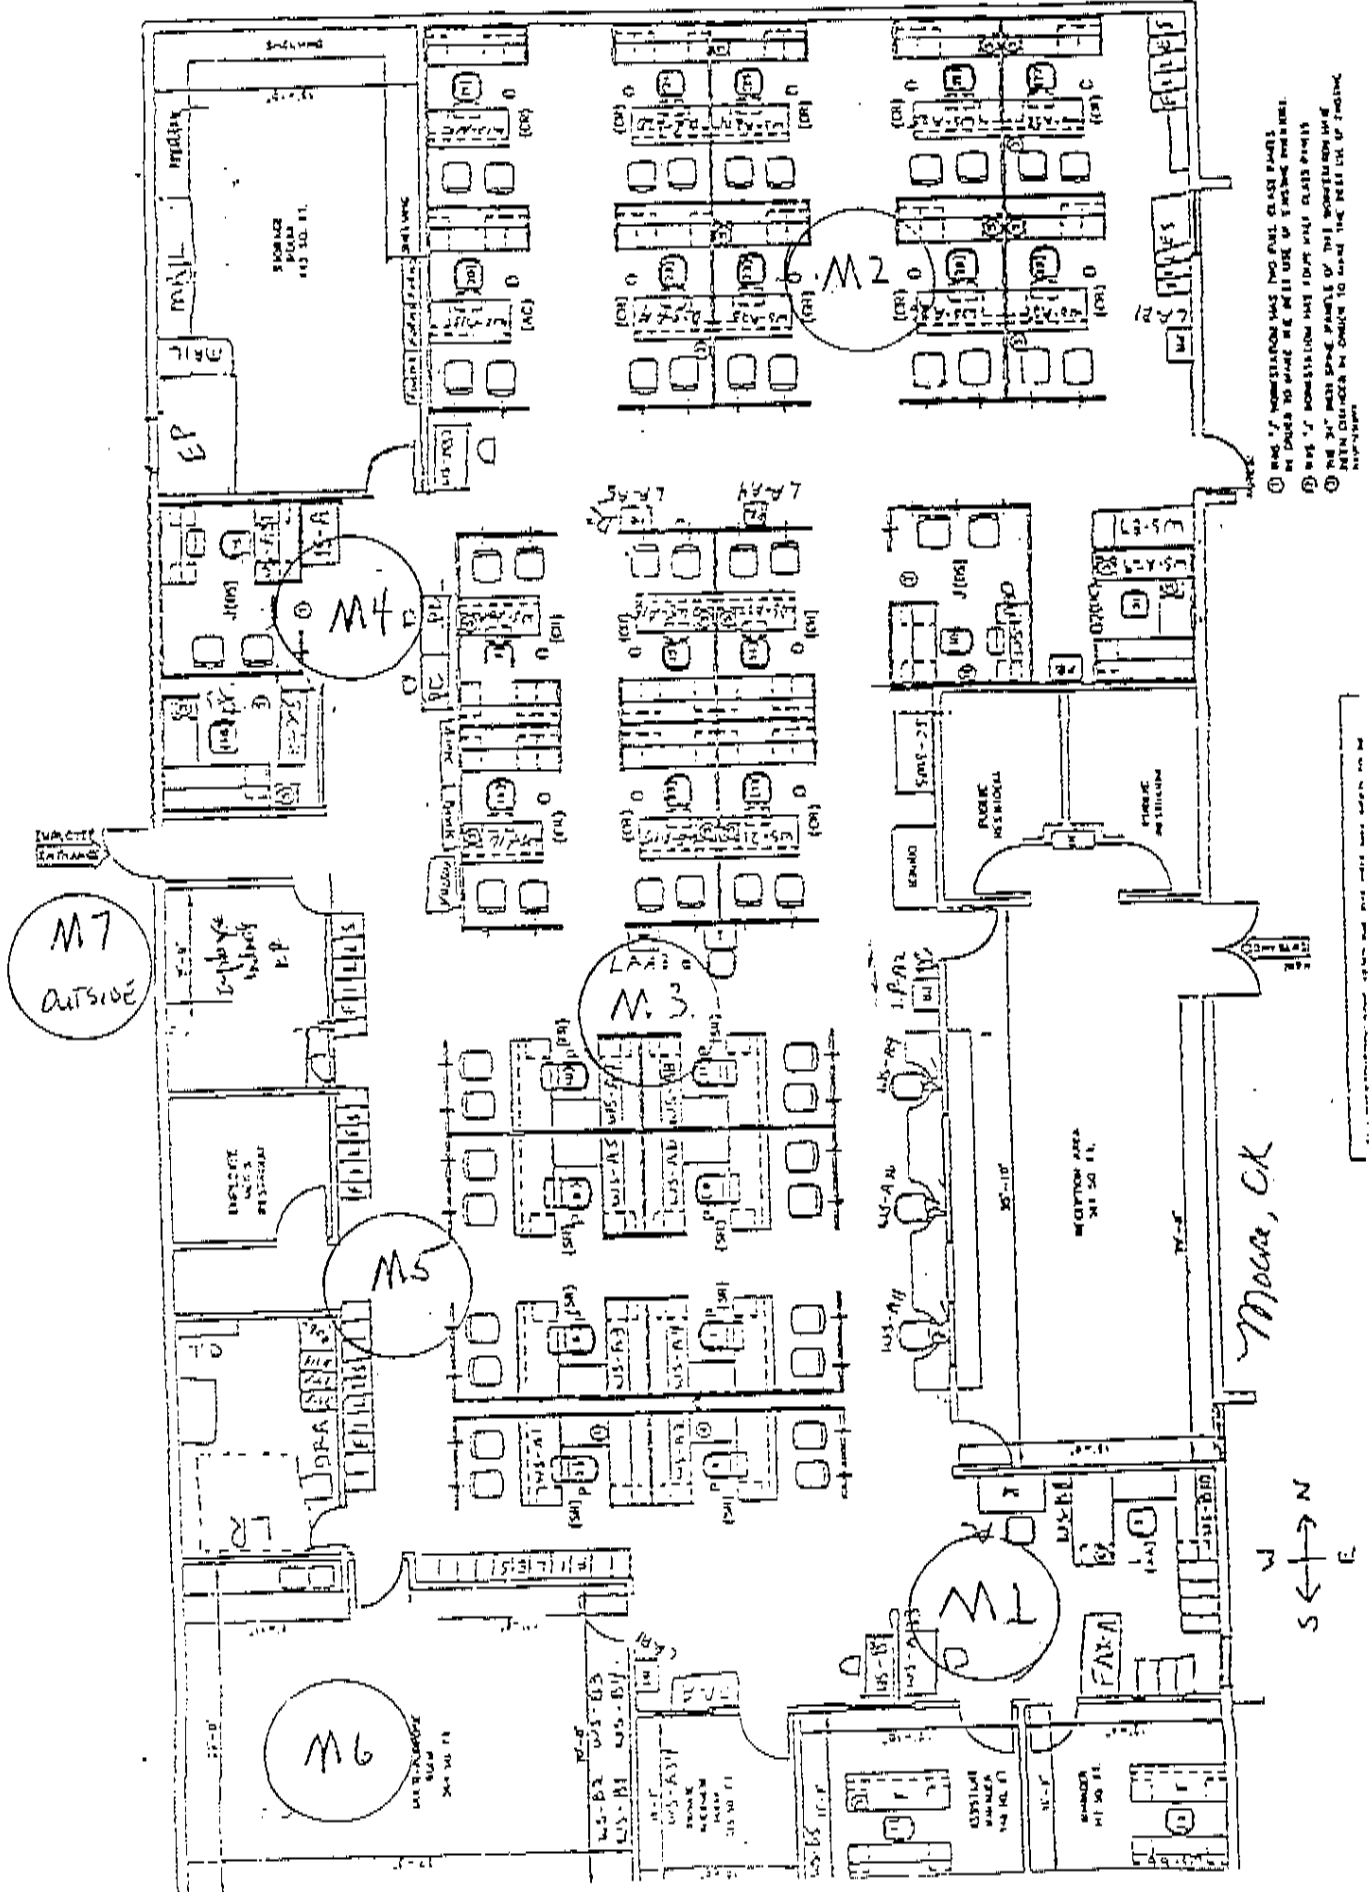
APPENDIX A

*Table - Temperature, Percent Relative Humidity, Carbon Dioxide and Carbon Monoxide Levels.
Floor Plan with Sample Locations.*

Carbon dioxide, carbon monoxide, temperature and relative humidity measurements were collected at six different locations within the SSA office. Also, these same parameters were measured outside the building. Measurements were collected three times during the work day; early morning, mid-day and late afternoon. The sample locations are designated as M1 through M6 within the building and location M7 is outside the building. The range of the monitoring results inside the building are shown below. The units for carbon dioxide and carbon monoxide are in parts per million (ppm). Temperature is in degrees Fahrenheit and relative humidity is in percent. Table I in Appendix A presents specific location, time and measurement results.

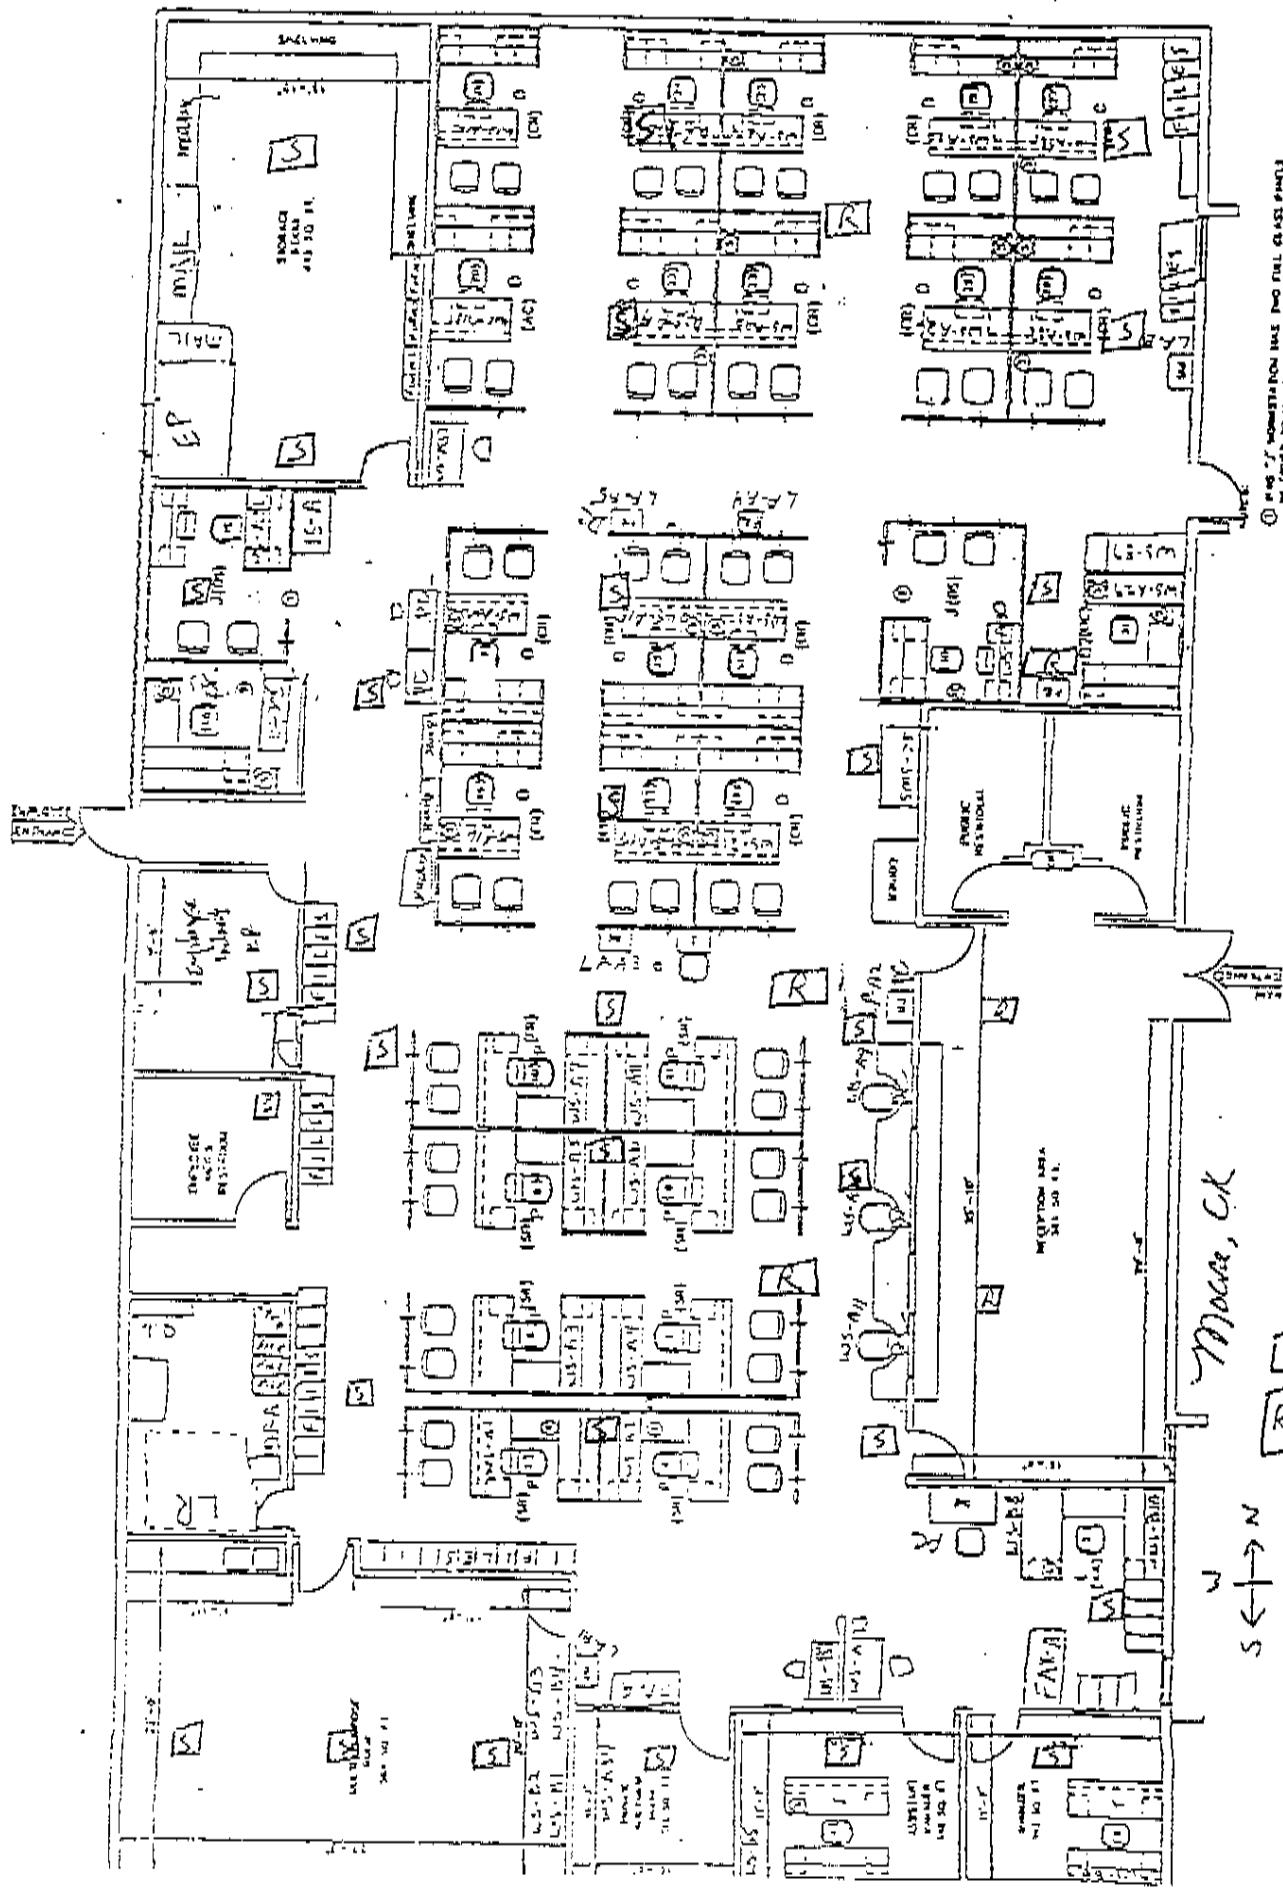
APPENDIX B

Floor Plan with Supply Registers and Return Grill Locations.
