INITIAL ASBESTOS INSPECTION

HUGO FIELD OFFICE
SOCIAL SECURITY ADMINISTRATION
2400 EAST JACKSON STREET
HUGO, OK 74743

SOCIAL SECURITY ADMINISTRATION CODE 789
GSA BUILDING NUMBER OK1481

MAY 16, 2008

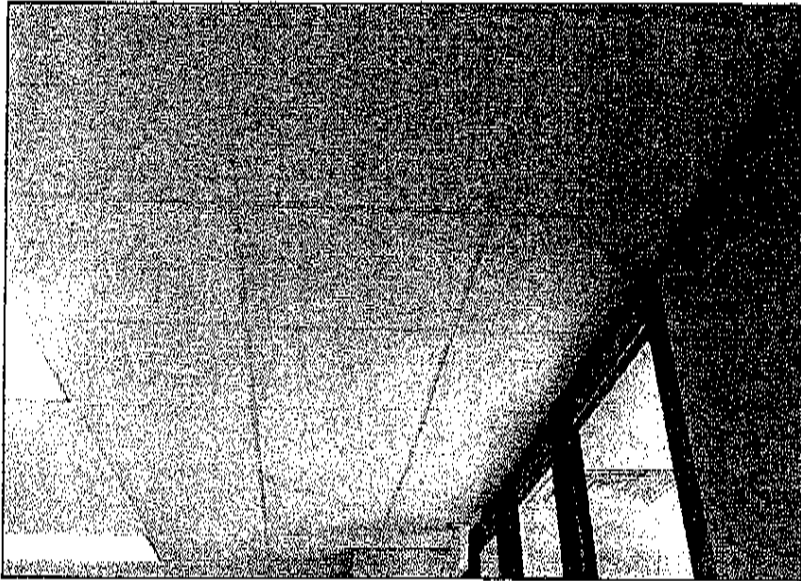
Photograph 1

Sample No. 06-0789-A001B-A005B
CEILING TILE, 2' x 2' white random fissure ceiling tile

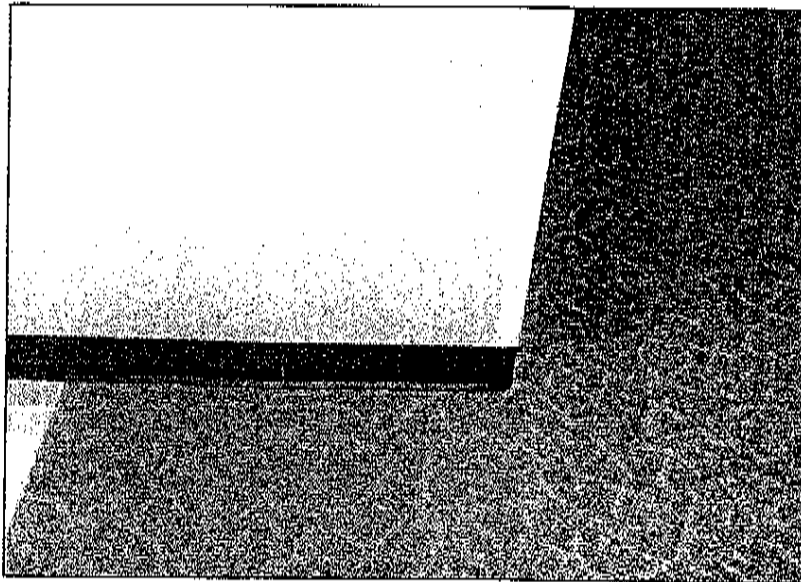
Photograph 4

Sample No. 06-0789-A019B-A021B (wall vinyl base cove) / Sample No. 06-0789-A022-A024B (adhesive)
WALL VINYL BASE COVE & ADHESIVE, 4" black wall vinyl base cove & associated adhesive

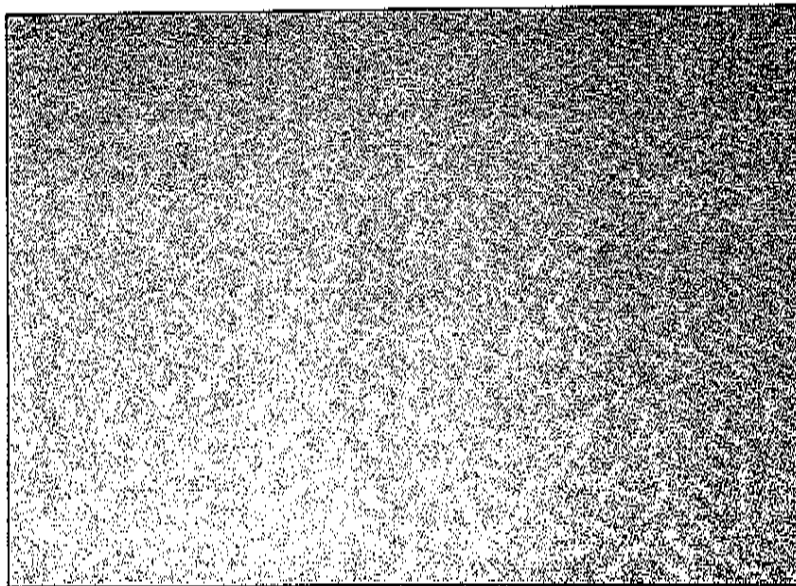
Photograph 6

Sample No. 06-0789-A031B-A033B
CARPET MASTIC

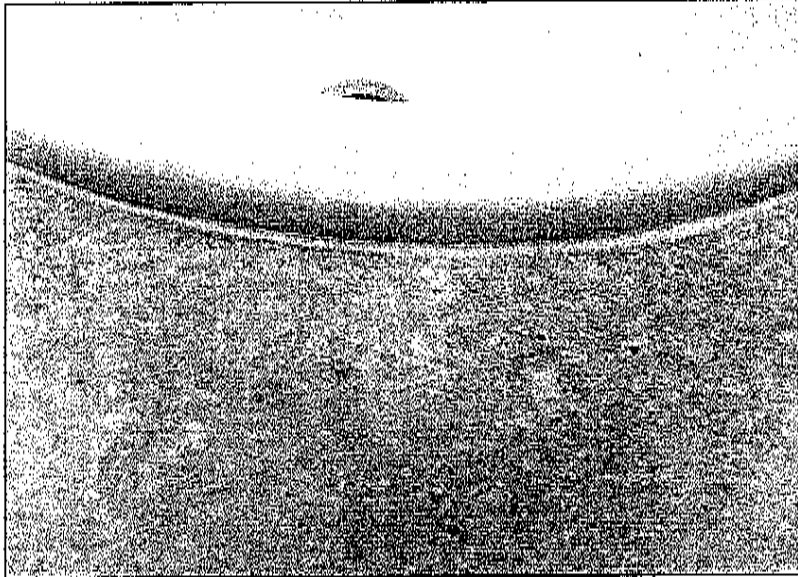
Photograph 7

Sample No. 06-0789-A034B-A036B
CAULKING

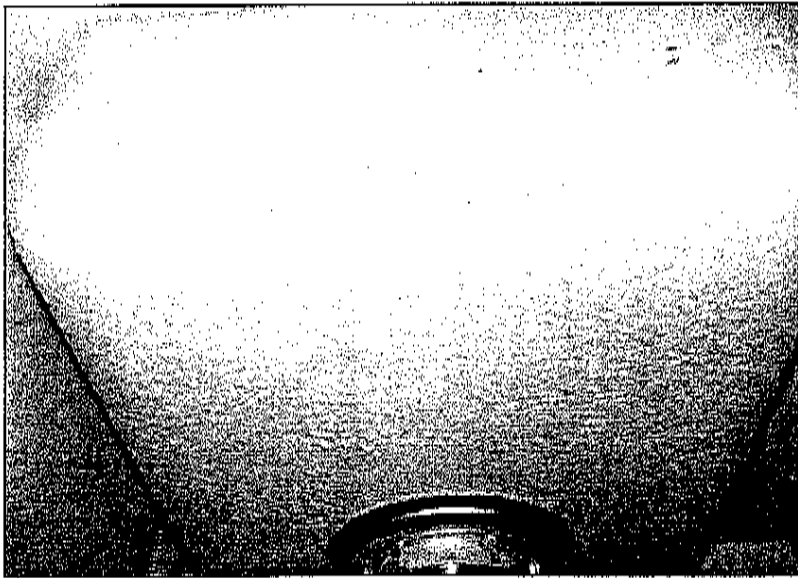
Photograph 8

Sample No. 06-0789-A037B-A039B
SINK UNDERCOATING

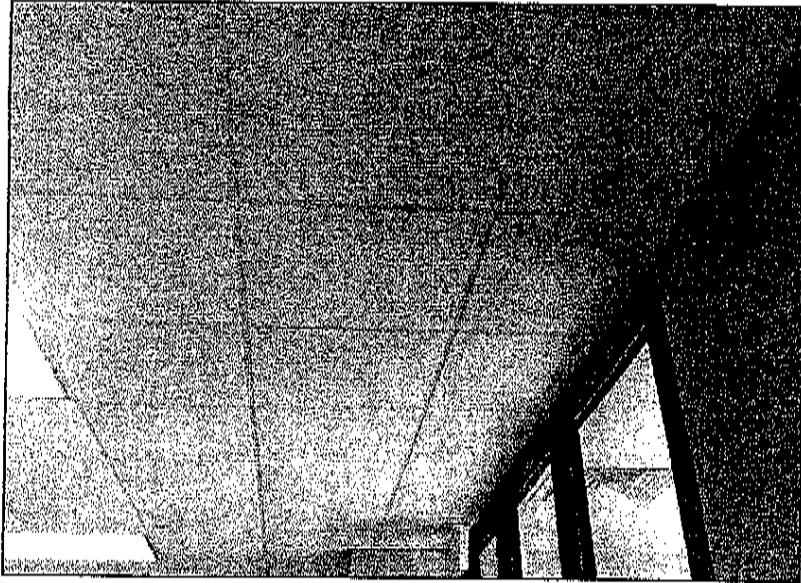
Photograph 1

Sample No. 06-0789-A001B-A005B
CEILING TILE, 2' x 2' white random fissure ceiling tile

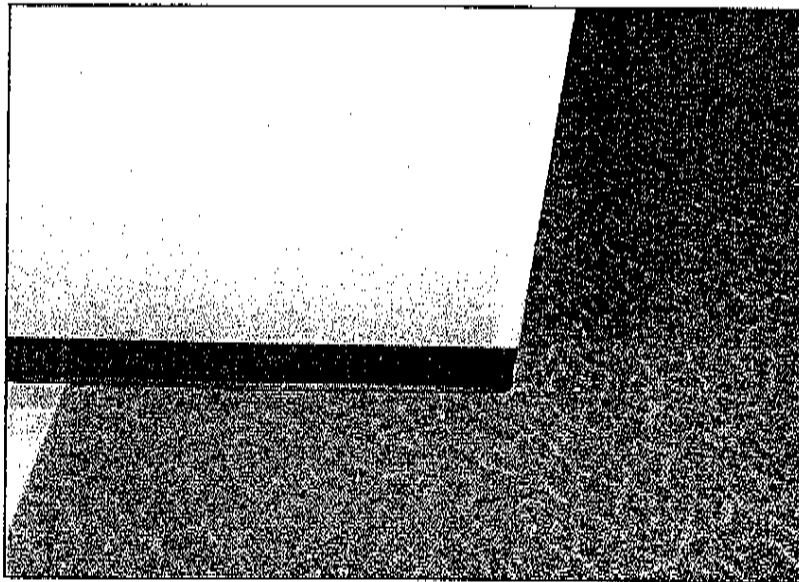
Photograph 4

Sample No. 06-0789-A019B-A021B (wall vinyl base cove) / Sample No. 06-0789-A022-A024B (adhesive)
WALL VINYL BASE COVE & ADHESIVE, 4" black wall vinyl base cove & associated adhesive

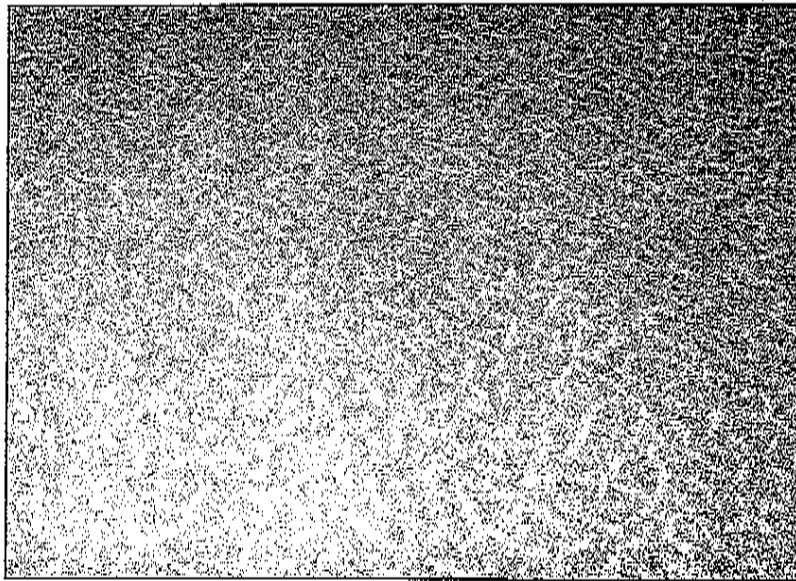
Photograph 6

Sample No. 06-0789-A031B-A033B
CARPET MASTIC

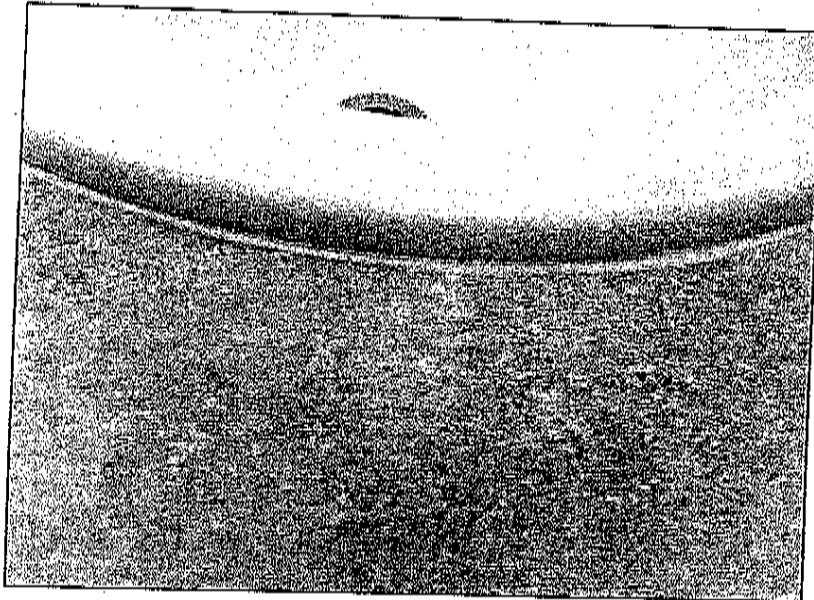
Photograph 7

Sample No. 06-0789-A034B-A036B
CAULKING

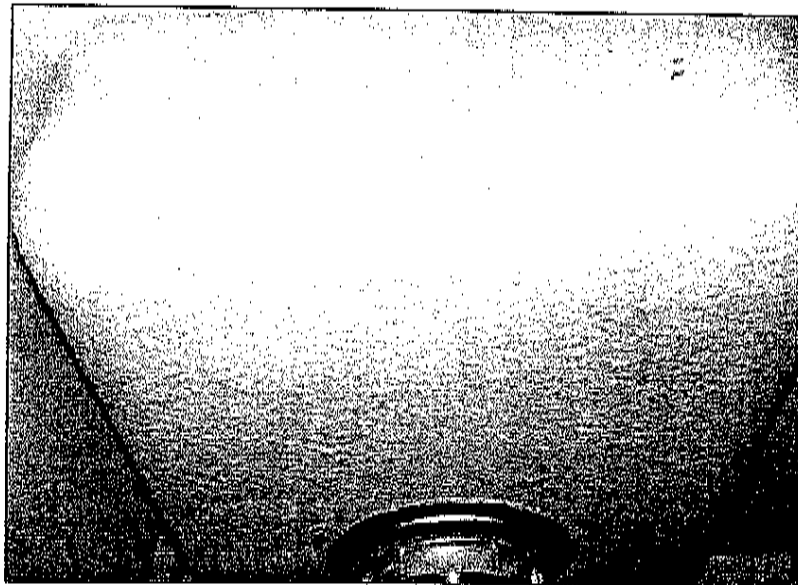
Photograph 8

Sample No. 06-0789-A037B-A039B
SINK UNDERCOATING
