Subject: Initial Asbestos Inspection Report for The Chickasha, OK SSA District Office

INITIAL ASBESTOS INSPECTION

CHICKASHA FIELD OFFICE
SOCIAL SECURITY ADMINISTRATION
506 W. UTAH AVENUE
CHICKASHA, OK 73018

SOCIAL SECURITY ADMINISTRATION CODE 785
GSA BUILDING NUMBER OK1277

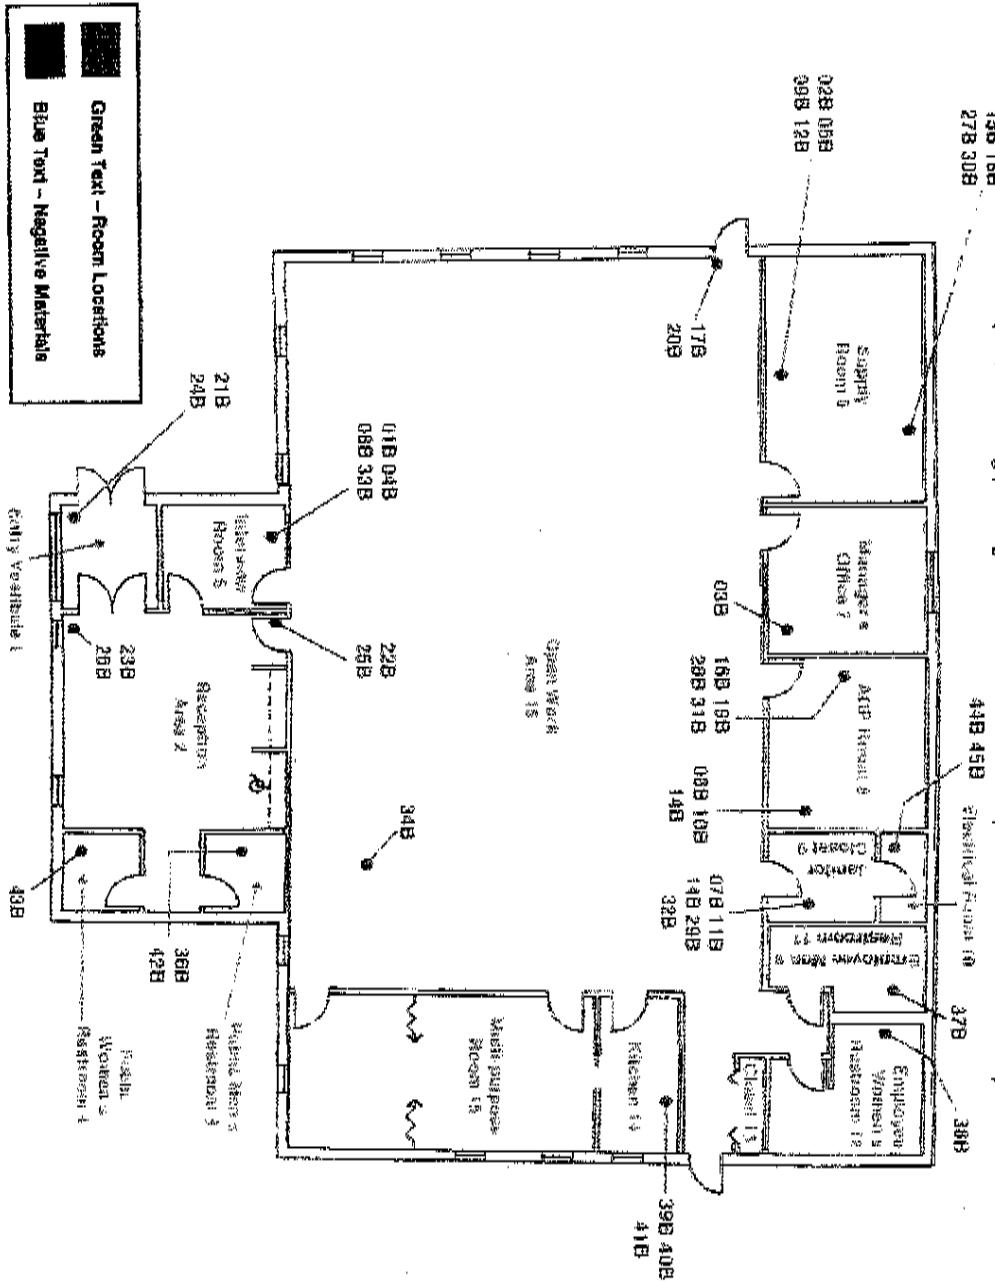
**CHICKASHA FIELD OFFICE LAYOUT (789)
SAMPLE LOCATIONS AND NEGATIVE MATERIALS**

(The following prefix goes in front of each sample number 06-0785-A0)
