Subject: Initial Asbestos Inspection Report for The Bartlesville, OK SSA District Office

INITIAL ASBESTOS INSPECTION

BARTLESVILLE FIELD OFFICE
SOCIAL SECURITY ADMINISTRATION
300 LEISURE LANE
BARTLESVILLE, OK 74006

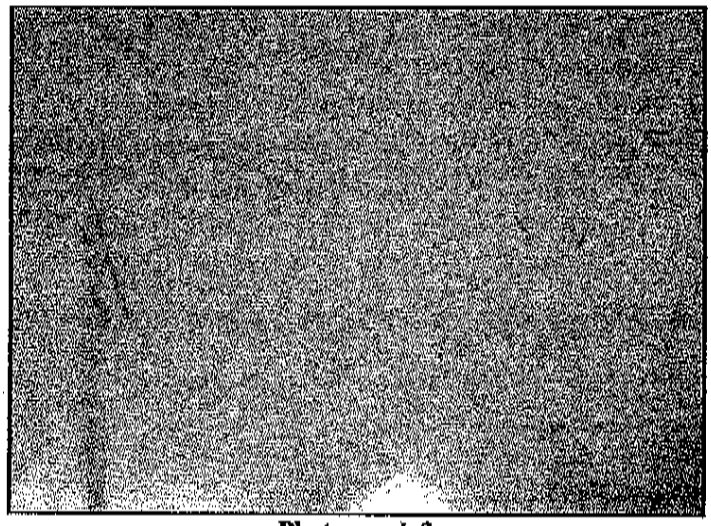
Photograph 3

Sample No. 06-0794-A025B-A027B (floor tile) / Sample No. 06-0794-A028B-A030B (adhesive)
FLOOR TILE & ADHESIVE, 12" x 12" white with blue streaks floor tile & associated adhesive

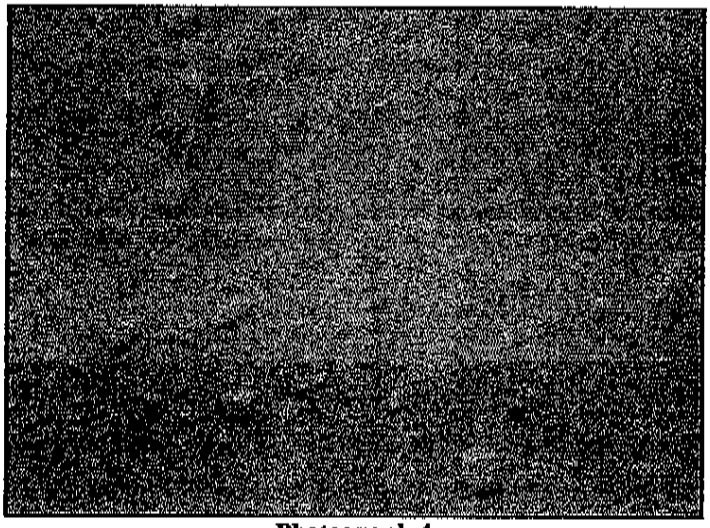
Photograph 4

Sample No. 06-0794-A004B-A008B
WALLBOARD

Sample No. 06-0794-A009B-A013B
JOINT COMPOUND

Sample No. 06-0794-A014B-A018B
TEXTURE, wall/ceiling
